**NATIONAL
TRANSPORTATION
SAFETY
BOARD**

AIRCRAFT ACCIDENT REPORT

**DELTA AIR LINES, INC.,
LOCKHEED L-101 1-385-1, N726DA
DALLAS/FORT WORTH -
INTERNATIONAL AIRPORT, TEXAS
AUGUST 2, 1985**

NTSB/AAR-86/05

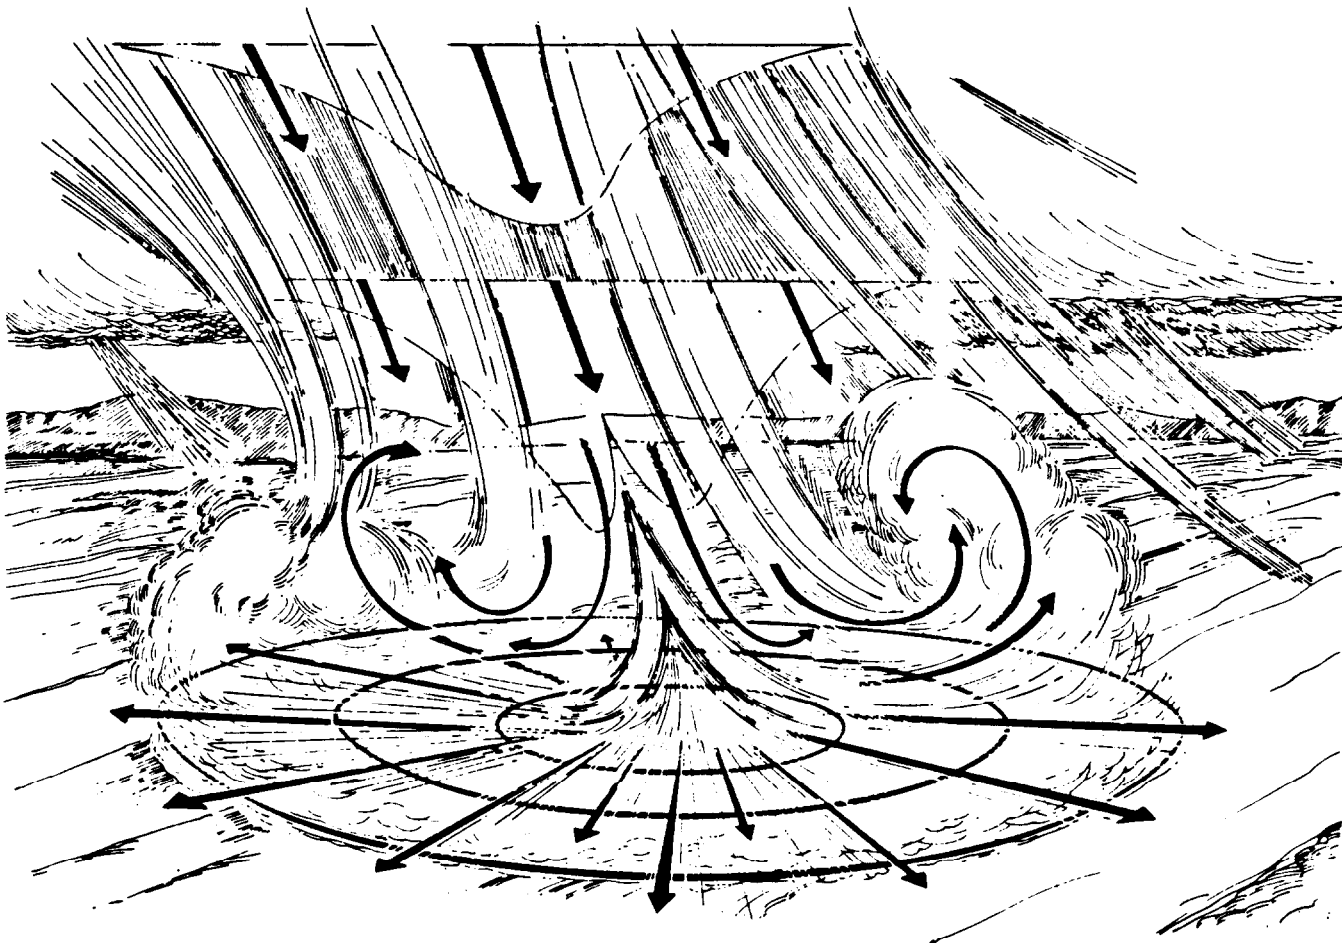
Figure 4.--Typical microburst wind field.

When a microburst is encountered during a landing approach, the airplane will typically experience an increasing headwind, a downdraft, and a decreasing headwind in rapid succession as it passes beneath the outflow and descending air column. The increasing headwind will be recognized as the indicated airspeed increases suddenly and the airplane tends to rise above the glidepath. However, this apparent increase in airplane performance is shortlived as the airplane enters the downdraft and encounters the decreasing headwind caused by the reversal in the direction of the outflow. The rapid reversal of wind direction and speed produces sudden changes in the airplane's angle of attack and airspeed, which may reduce the airspeed far below the initial stabilized airspeed. The reduced airspeed will result in reduced vertical lift, causing the airplane to accelerate downward. Further more, the airplane's longitudinal stability will cause the airplane to pitch nose downward as it attempts to reacquire its trim speed equilibrium. The extent to which the airplane's flight path changes depends upon the severity of the windshear and the pilot's reaction with flight controls and engine thrust. The microburst might also create horizontal vortices which produces sudden changes of vertical wind speeds to further upset the longitudinal stability and perhaps the lateral and vertical stability of the airplane, exacerbating the pilot's control task.
